**Re: 2016 Inspections of B Bar K Cascade Ranch Dams: Woodrat Knob (W-43); Lake Creek (L-24); Osborne (O-15) Bradshaw 1 and 2 (B-24, B-83), Frog Pond (F-30), Harrison (H-47)**

## Results of Inspection – Lake Creek L-24

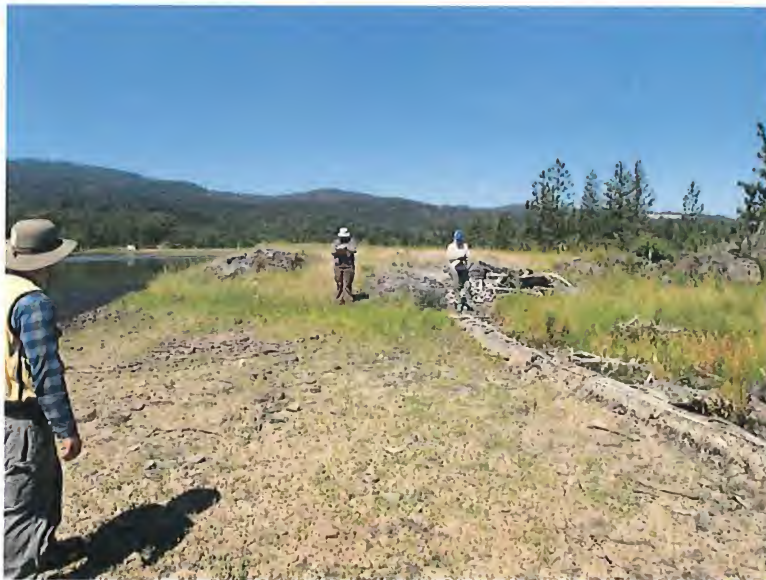
Spillway control section with reservoir in background

The reservoir level was 9.2 feet below the dam crest when inspected. Minimum freeboard was 4.2 feet. Based on measurements and analysis, the spillway capacity appears sufficient to pass an extreme flood. The reservoir was clean.

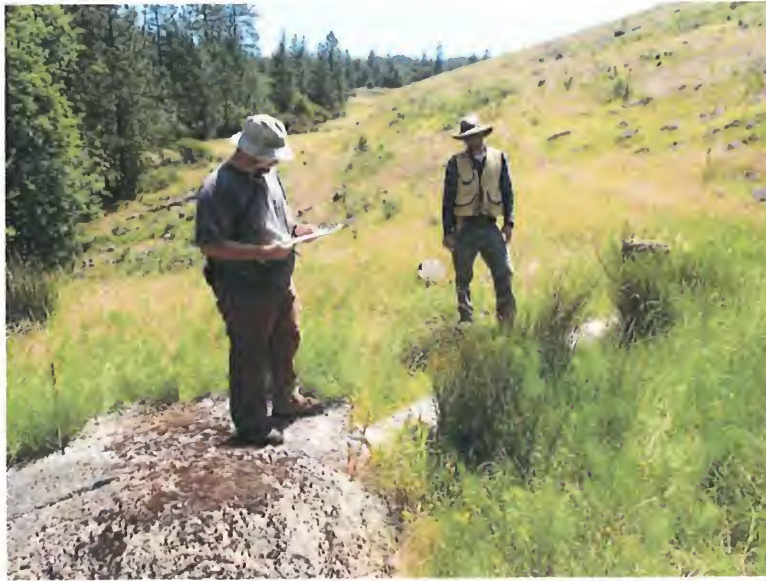
Low level conduit is deteriorated

The corrugated metal culvert that serves as the low level conduit through this dam continues to deteriorate slowly. The holes are slightly larger, and there is also a cut in the pipe from we believe an engineers' attempt to evaluate the conduit with a remote camera. If the valve is completely open, it is very likely to leak significantly from these locations, and cause erosion of the embankment and native materials in this general location.

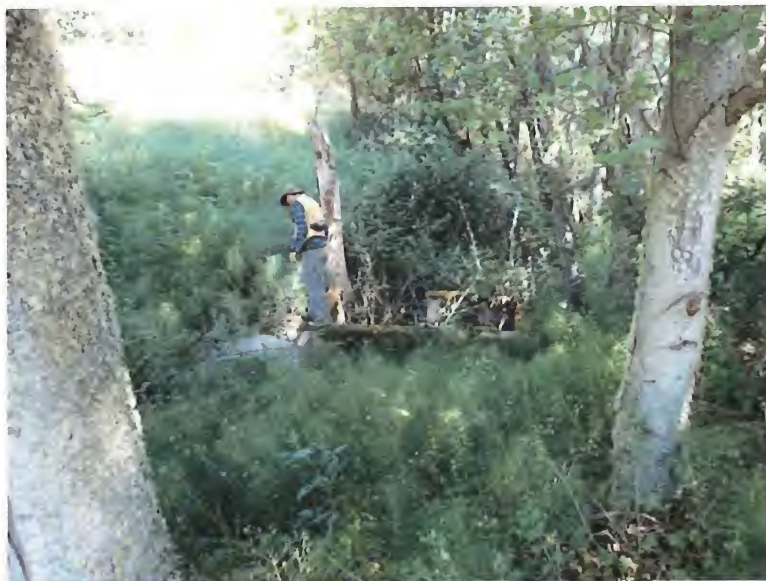
Outlet structure disconnected

The outlet works structure is heavily overgrown, and generally disconnected from the outlet pipe. The ground in this area is always wet and poorly drained, as evidenced by the

foxtail plants that are growing all around it. The trees (red alders) are also causing damage to the outlet structure.

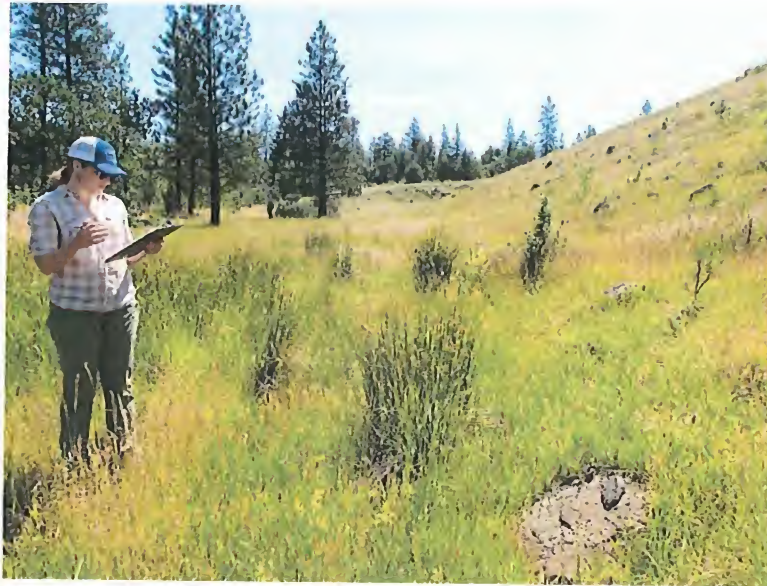
Excellent vegetation cover, some seepage

Both the upstream and downstream faces have a well maintained cover of grass, with very little woody vegetation. The only sign of seepage was in a few areas around the toe, with no observed leakage through the dam. We saw no sign of significant settlement or other indications of embankment instability.

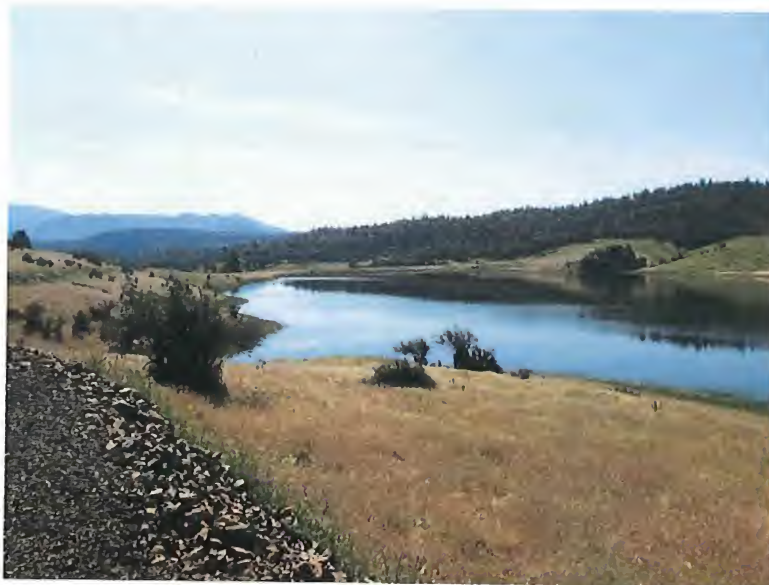
Reservoir with dam in background

The reservoir level was 9.5 feet below the dam crest when inspected. Minimum freeboard was 6.3 feet, which is excellent. The reservoir was clean, with no logs or debris near the

dam. Both the up and downstream faces have a well maintained grass cover. The access and security at the dam are both good.

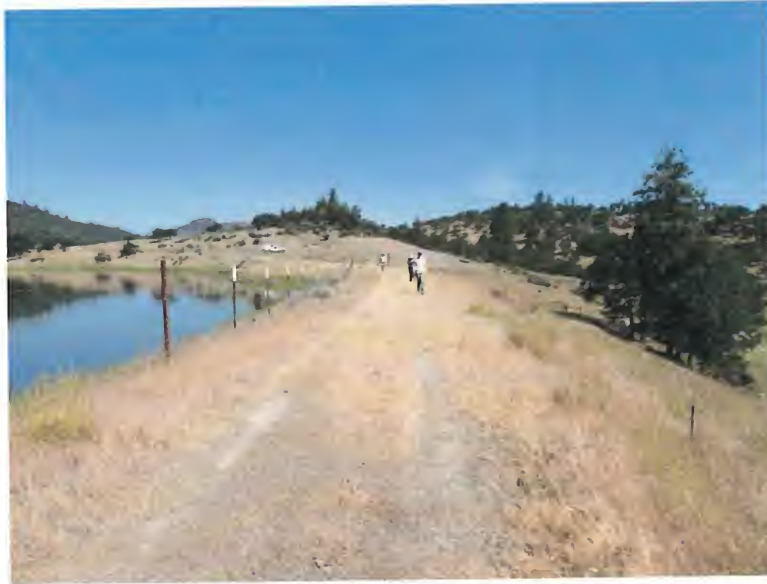
Crest of dam

The crest of the dam shows no sign of instability. There is no sign of reactivation of movement that caused a near failure of this dam in 1961. However, we have no information on water pressures inside the dam, as the piezometers (one shown on the downstream face in the photo above) have long been out of service.

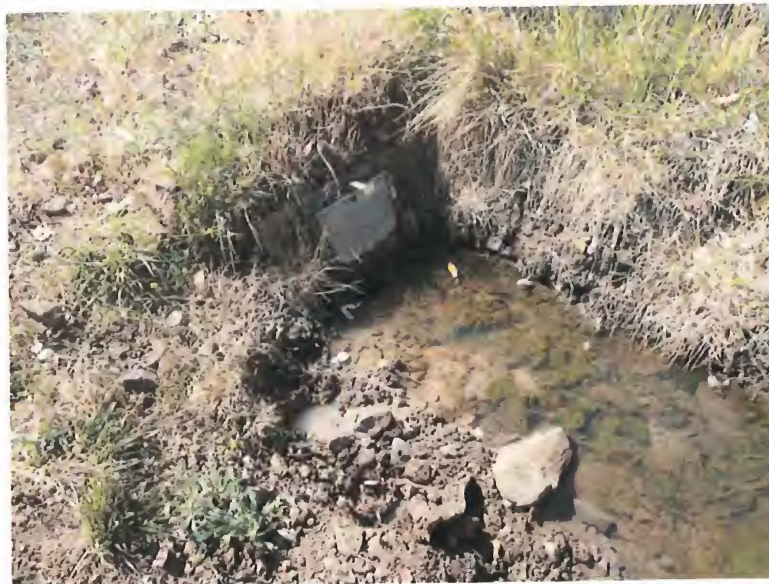
Outlet of conduit

This dam has no low level outlet, probably because of the aforementioned near failure. This 18 inch culvert was placed at mid-elevation after that near failure. The culvert has deteriorated badly, and has reached the point where action is necessary to prevent this from becoming an unsafe condition. This culvert should be inspected if possible and either replaced, or if safe, relined.

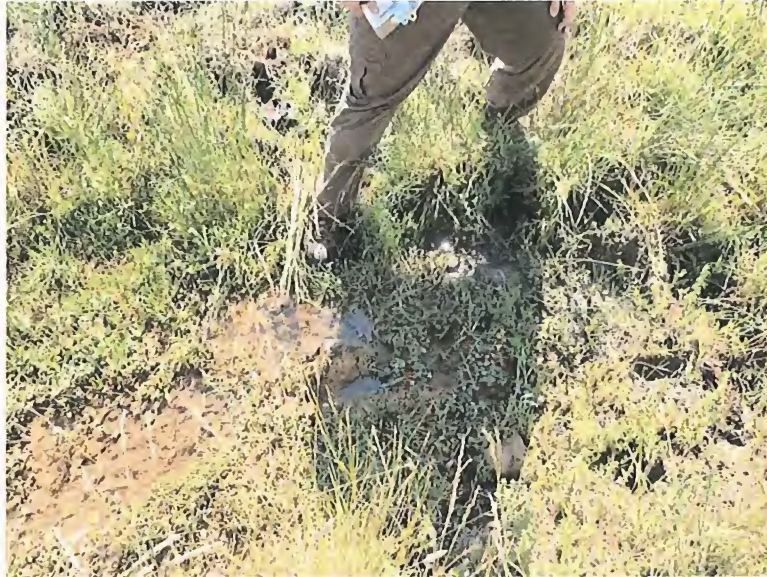
Seepage from failed drains

The seepage is caused by blockages and failure of the culverts installed in the early 60's to stabilize the dam after the major landslide. New drain pipes are necessary to ensure the stability of the berm and its ability to keep the dam stable. These drains are believed critical, as they reduce water pressures within the dam. Excess water pressure from water seeping through the dam likely caused the large failure in 1961.

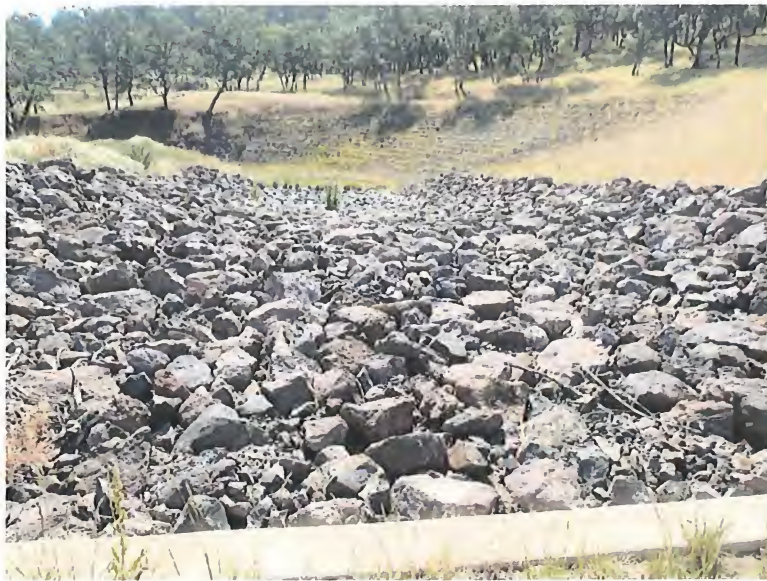
New spillway

The new spillway had flow for the first time in the winter and early spring of 2016. The spillway handled these flows with no erosion at all. This structure has greatly improved the safety of Woodrat Knob dam, at least in eliminating the potential of an overtopping failure due to a flood.

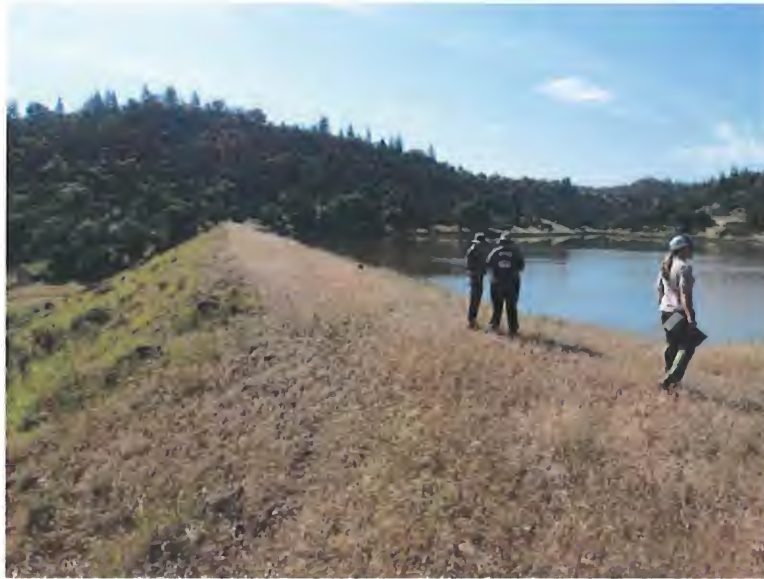
Reservoir and crest of dam

The reservoir level was 10.2 feet below the dam crest when inspected. Minimum freeboard was 4.5 feet, which is adequate. There is a little more woody vegetation on Osborne dam than on the other two dams inspected during this trip. The crest and embankment appear stable.

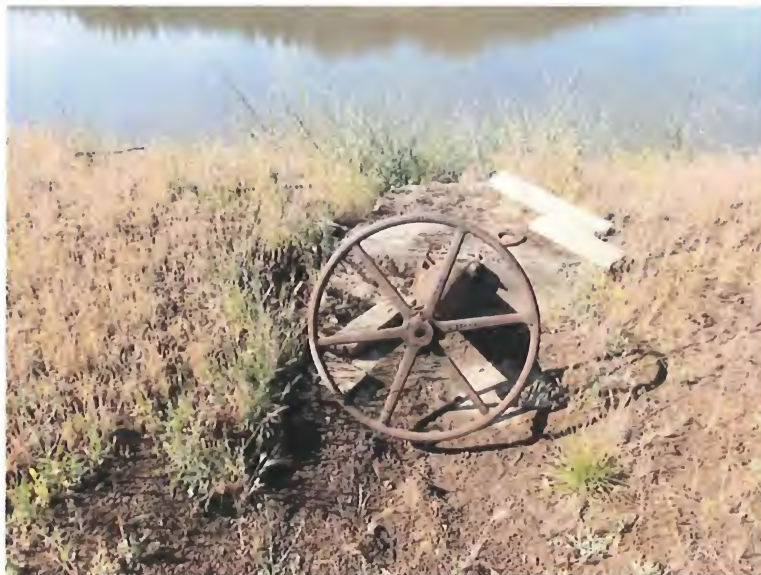
Valve was cycled

The control was operated for the first time in the last 5 years. It is nearly past its useful life. You will need an alternative that will be essential for draining water from the dam, both for maintenance, and in the event of an emergency. It may also be possible to construct a new outlet that is more conducive to your irrigation operations.

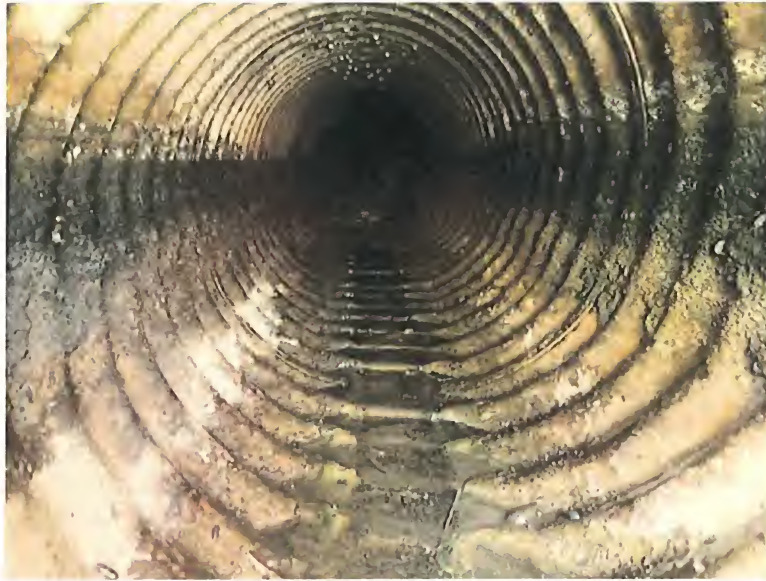
Inside of conduit

The inside of the outlet culvert is corroded, but we did not observe holes in the structure yet. This pipe will continue to deteriorate, and will become unsafe at some point in the not too distant future. On a positive note, you were able to operate the valve this year, and determine that both the valve and conduit are operational right now.

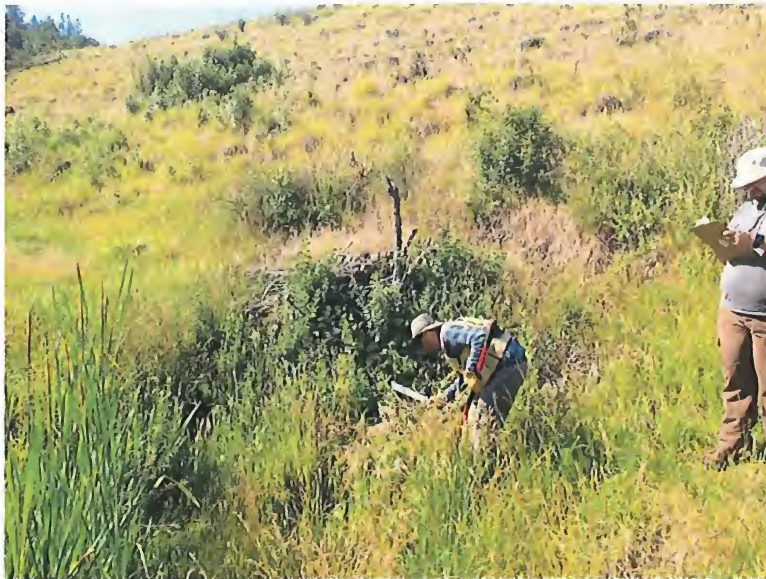
Brush regrowth around outlet

There is brush at the toe of the dam and there is seepage. The seepage is not collected, so it is not possible to determine if the rate of seepage is changing. The rest of dam has mostly grass cover and nothing restricts inspection. We observed no signs of instability on this dam, at this time.

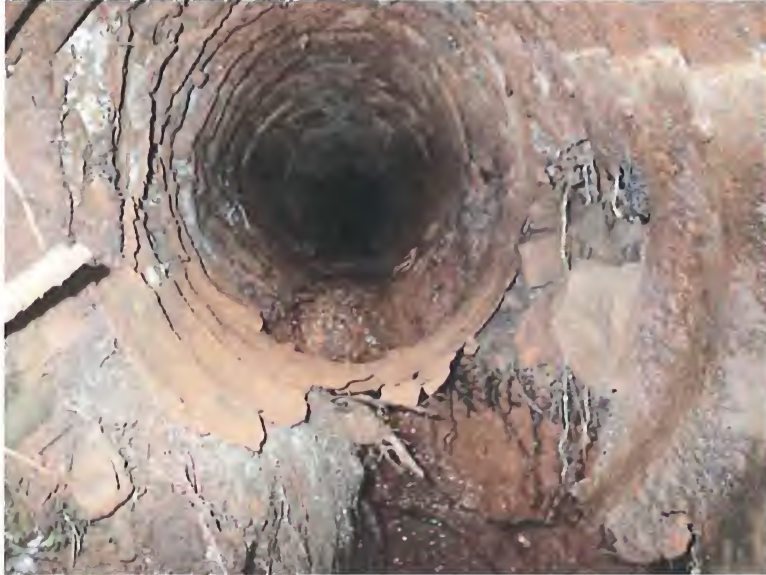
Deteriorated outlet conduit

There is water leaking from the low level outlet conduit. It is not clear if the leak is from within the conduit or from around the exterior of the conduit. The visible section of the corrugated metal pipe outlet is highly corroded and should be addressed.

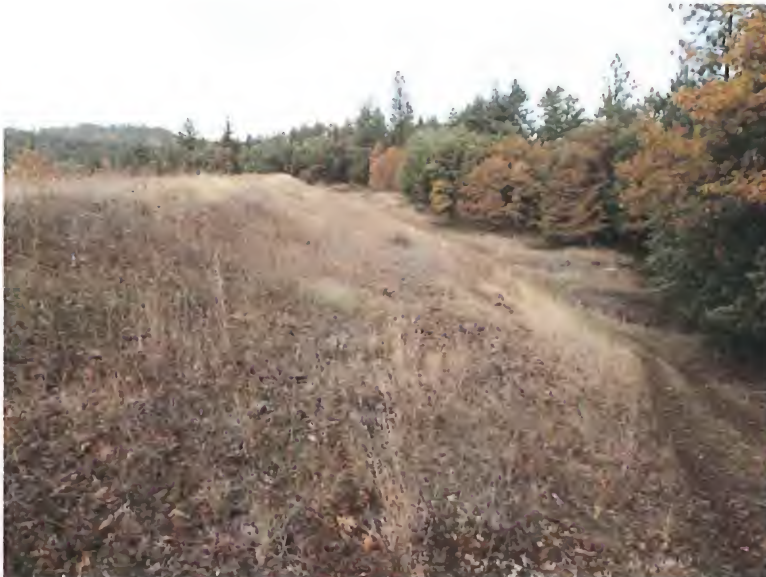
Main dam

The dam and auxiliary dam show signs of bovine activity. Cattle should be kept off these structures in order to preserve the integrity of the dam and its storage maximum capacity.

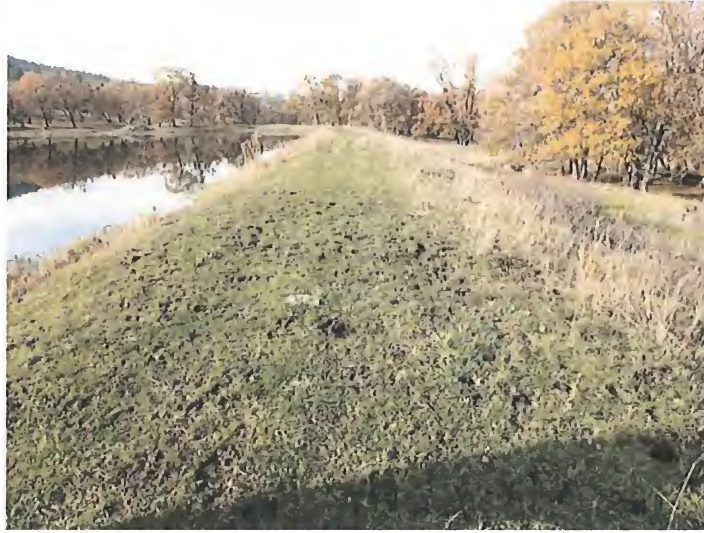
Cattle activity on the crest of the dam

There is abundant cattle activity along the crest and downslope of the dam. There is a clear pathway eroded on the downslope face that may promote erosion. Trampling of the crest can reduce freeboard and total storage of the reservoir. We recommended keeping cattle off the structure in the future in order to preserve its integrity in the long term. There are several small oak saplings along the down slope of the dam. These should be removed before they have the opportunity to compromise the structure.

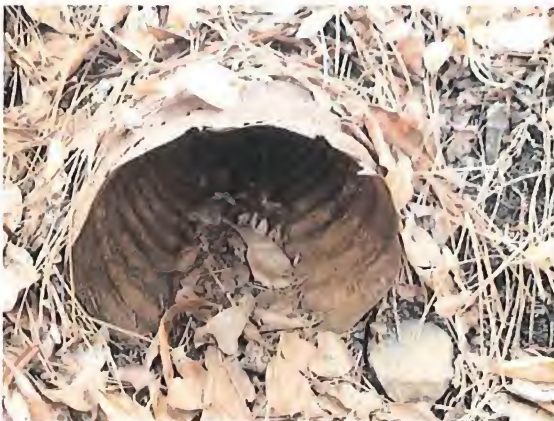
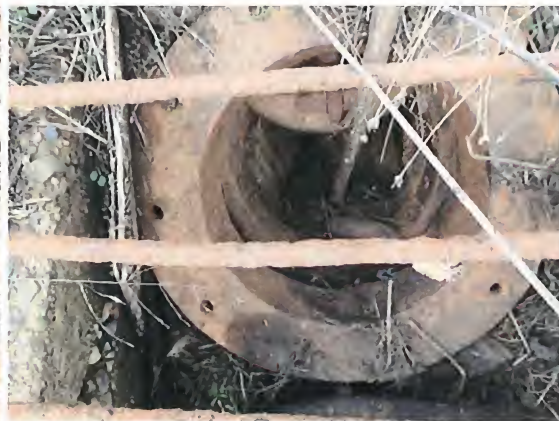
Outlet of low level conduit

Inlet to low level conduit

The inlets and outlet and control structure for the low level conduit are deteriorated with unclear functionality. We suggest cycling the outlet at least once per year to ensure the ability to release water in the event of an emergency.

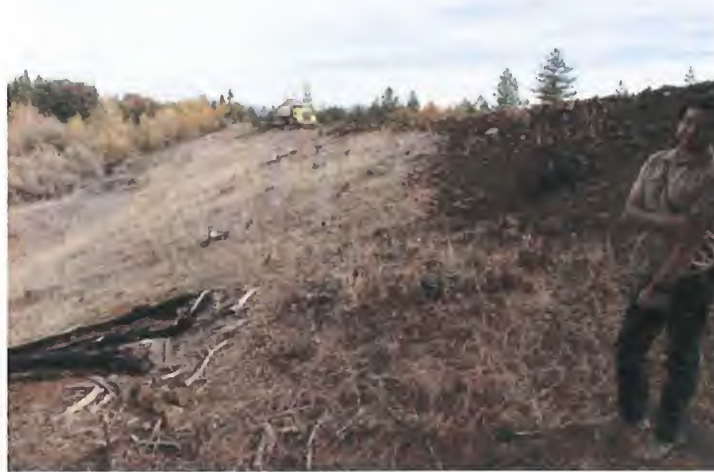
Road maintenance on the crest of the dam

This reservoir appears to not currently be in use. Please contact us if you put this dam back into service. We recommended that you continue regular on this structure in the interim.

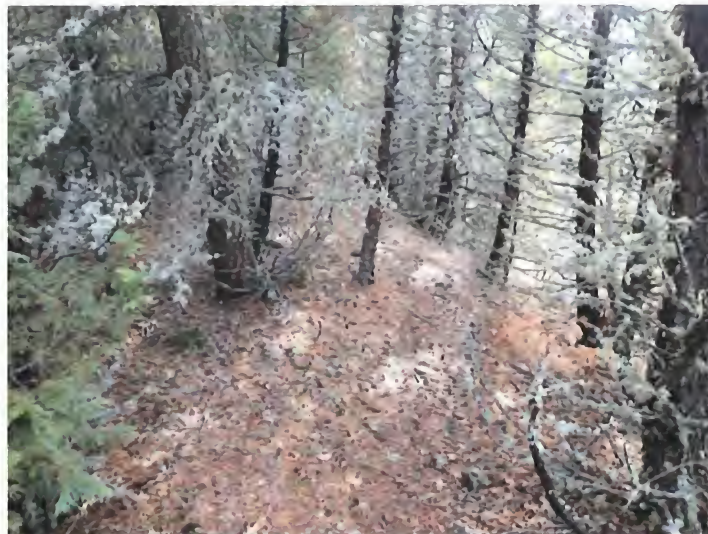
Numerous trees on auxiliary dam

While we were on site there appeared to be road improvement occurring along the crest of the dam. Any heavy equipment used may have lowered the crest and consequently the

available freeboard. Additionally, there was abundant vegetation growing along the left abutment, left auxiliary dike, and potentially within the channel of the spillway.

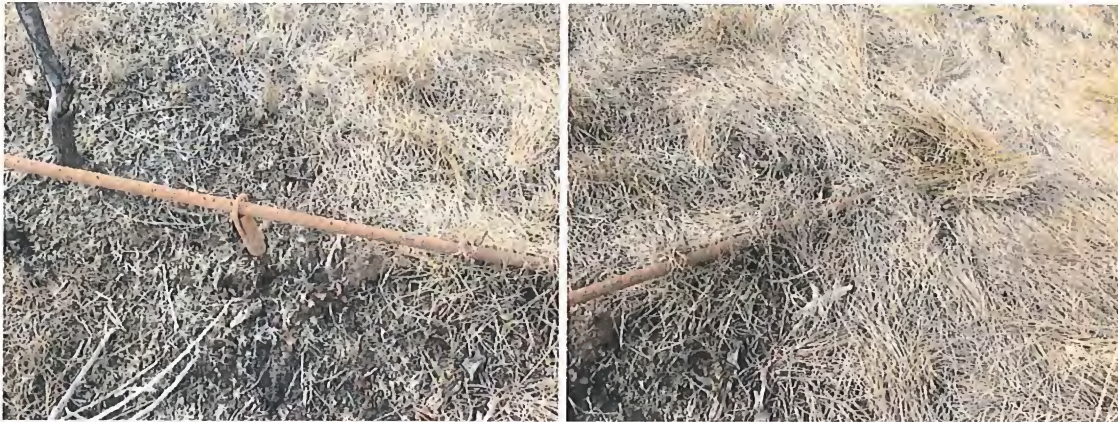
The control structures and outlet are corroded and partially buried. This may need to be addressed prior to resuming use of this reservoir. It is prudent the outlet be fully functional, as it is the only way to release water from the reservoir in the event of an emergency.
